AN OVERVIEW OF APPROACHES AND TECHNIQUES USED IN FAILURE ANALYSIS OF ENGINEERING SYSTEM

T. N. Guma*, N. C. W. Ozoekwe, and K. V. Oditia

Department of Mechanical Engineering, Nigerian Defence Academy, Kaduna, Nigeria

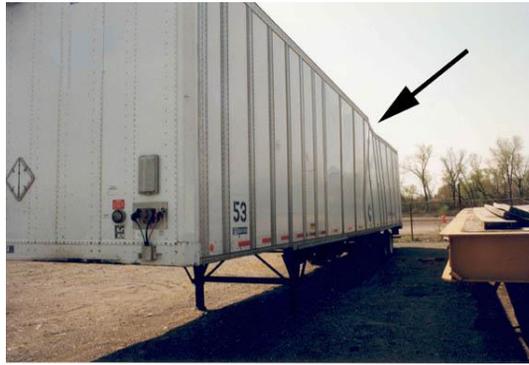
Figure 5: A typical van trailer

According to Roberts (2019), improper weight distribution can be a cause of structural failure in semi trailers. This can not only lead to the loss of the trailer, but also to the loss of cargo or even the possibility of an accident. He illustrated the following two case studies of losses caused by overloading semi-trailers. He depicted the view of a typical van trailer that sustained a sidewall failure in Figure 5 while carrying six pallets of copper wire, weighing approximately 3,178kg each.

He reported that the total load of 19,047kg in the trailer was unacceptable, according to the trailer manufacturer's load limit. The trailer manufacturer stipulated that a maximum concentrated load of 6,810kg in 3.048m of trailer length should not be exceeded (Roberts, 2019).
